QUINNIPIAC RIVER BASIN
WOODBIDGE, CONNECTICUT

LAKE WATROUS DAM
CT 00318

PHASE I INSPECTION REPORT
NATIONAL DAM INSPECTION PROGRAM

AUGUST 1978

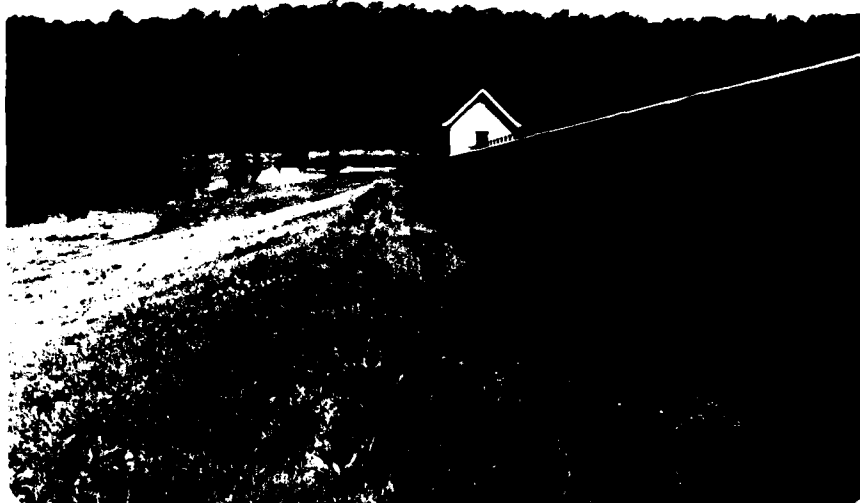
PHOTO NO.1 - General view of downstream face of dam and embankment.
